# **EXHIBIT D**

# Lead Cable Investigation

June 30, 2023

Marine Taxonomic Services, Ltd.  
Below the Blue 501(c)3

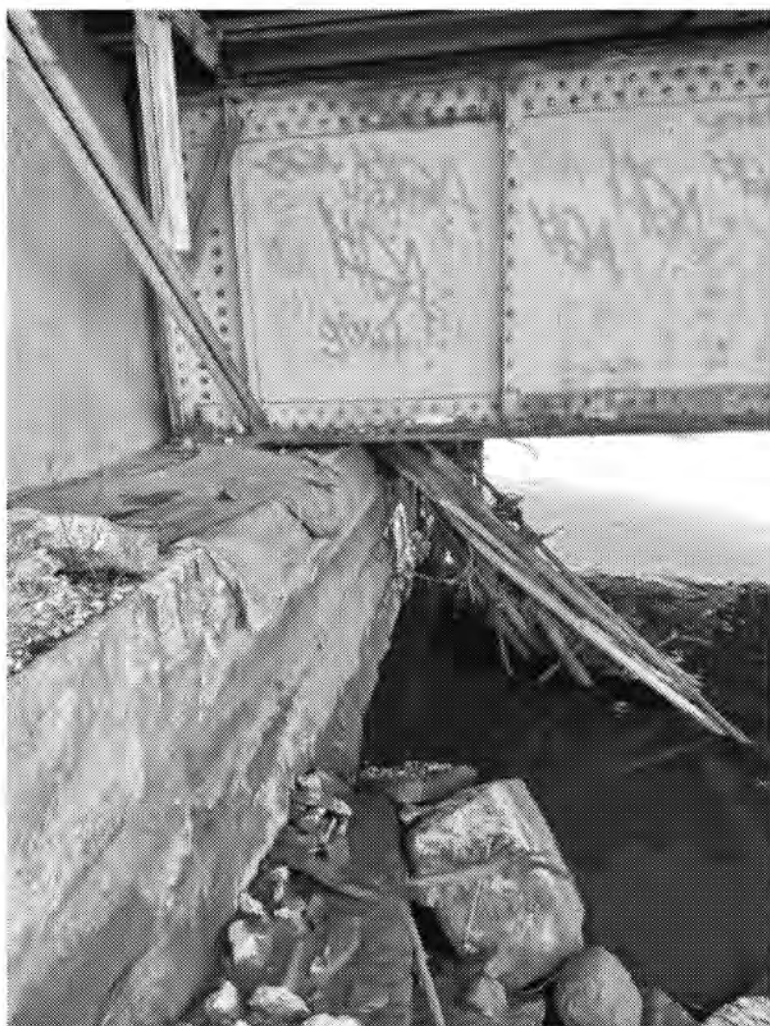
(H) Evidence of homeless sleeping next to these cables along the Passaic River. Passaic 2. January 2023, Harrison/University Heights, New Jersey.

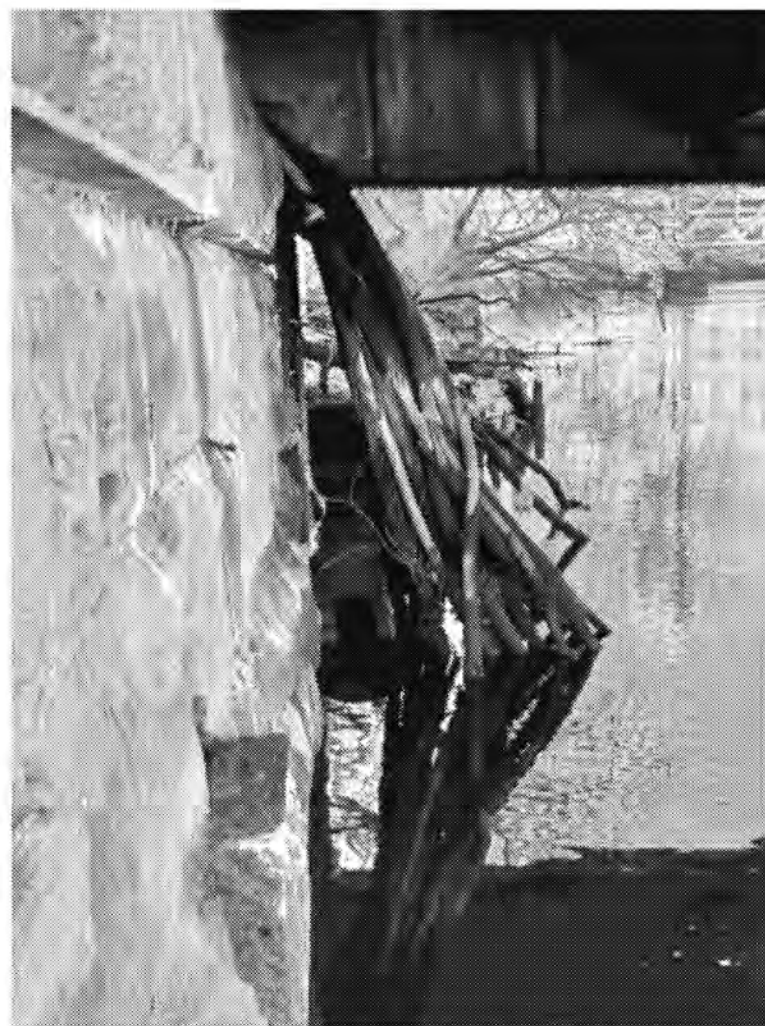
(I) Cable location with twenty lead sheathed cables underneath the Bridge Street Bridge (Harrison Ave.). Passaic 2.1 January 2023, Harrison/University Heights, New Jersey.

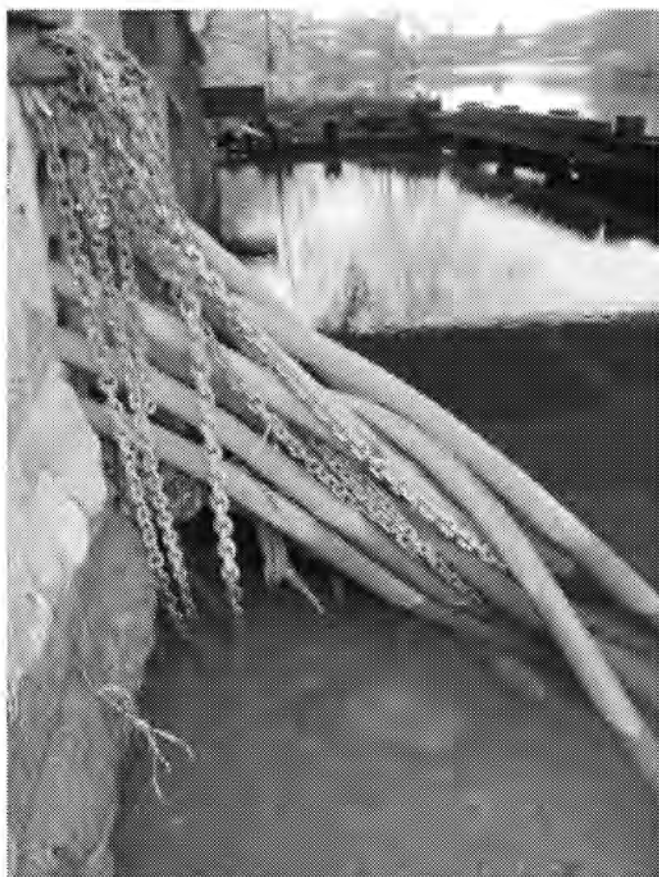
(J) Part of a complex site containing twenty-one cables near Washington Crossing State Park along the Passaic River, Passaic 5.10, January 2023, New Jersey.

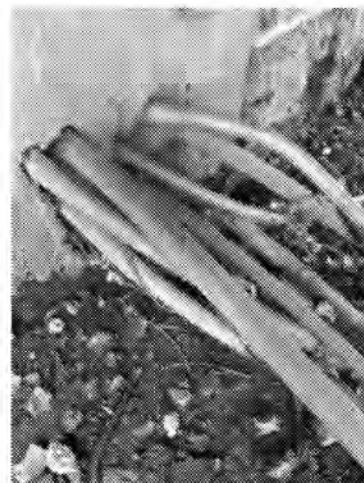
(L) Part of an eleven-cable location found near Wall Street Bridge, between Garfield and Wallington, Passaic 8, January 2023, New Jersey.

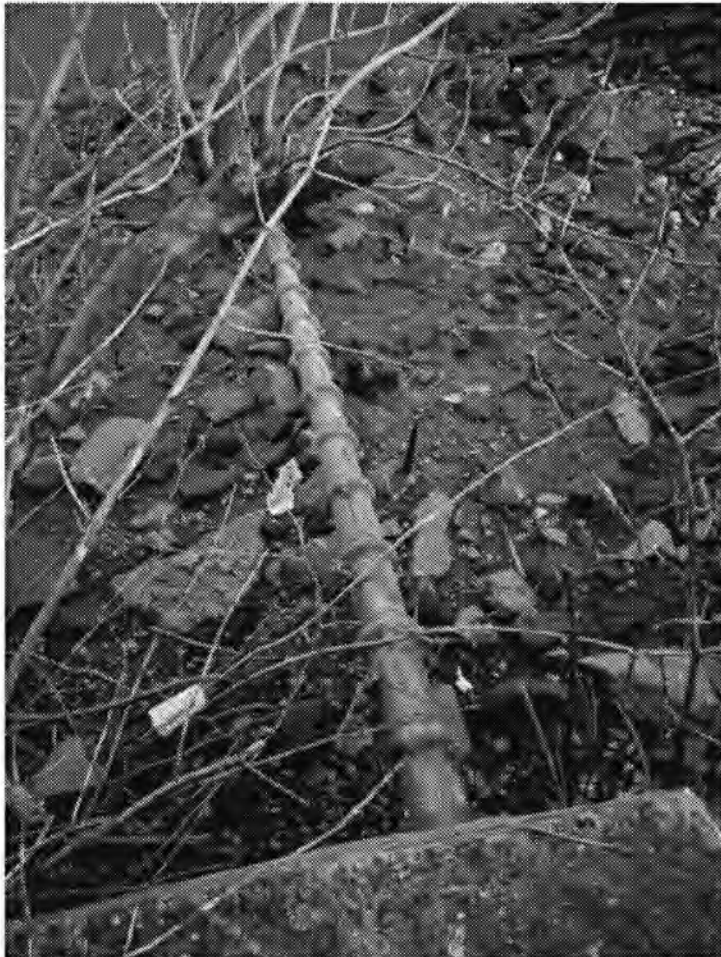
(A) Armored cable approximately fifteen feet from the water's edge. Passaic 3. January 2023, Belleville, New Jersey.

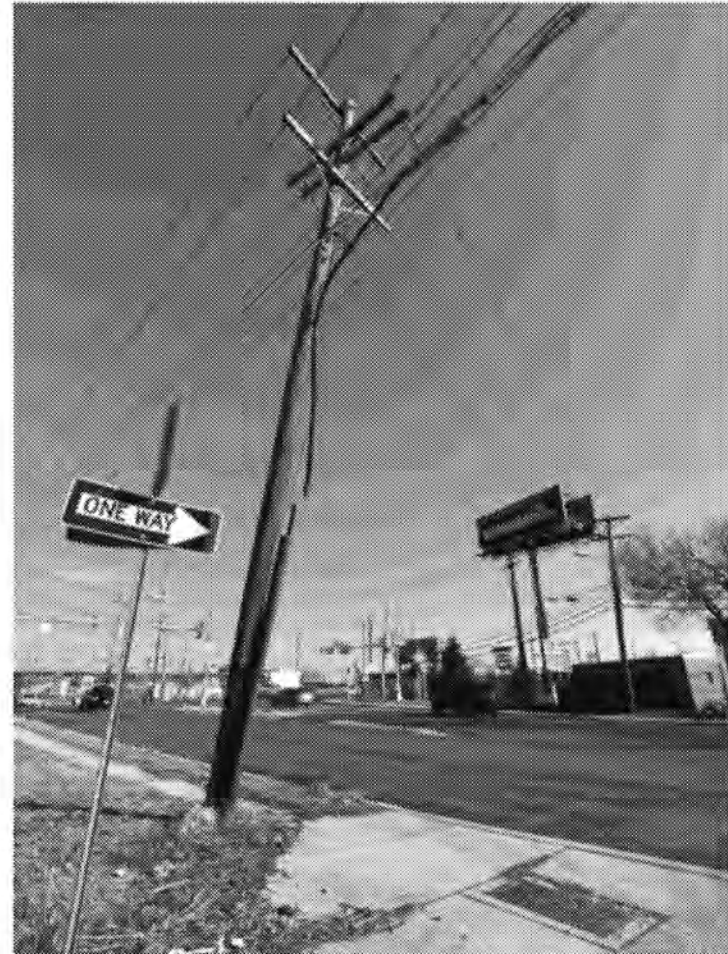
(B) Overhead cut, lead sheathed cables in the South Kearny area. There are two cables that run approximately 0.4 miles. South Kearny End A. January 2023, Kearny, New Jersey.

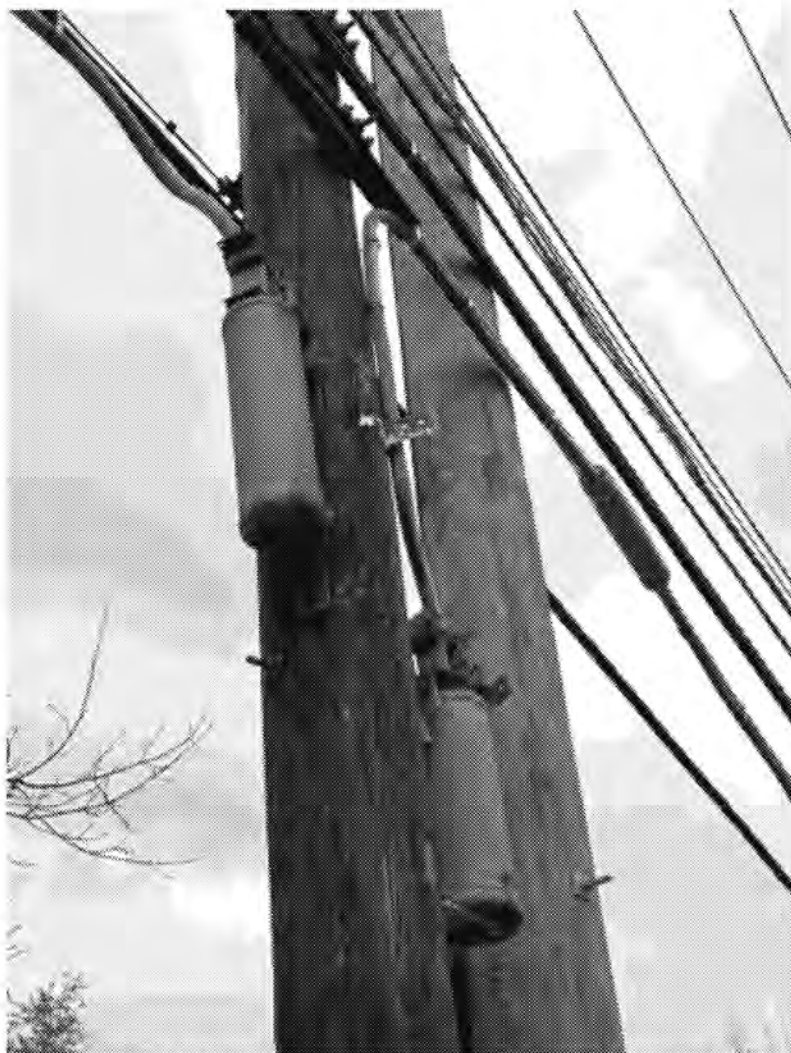
(A) Close up of telephone poles with overhead lead sheathed cable and leaded splice boxes. January 2023. Highland Falls, New York.

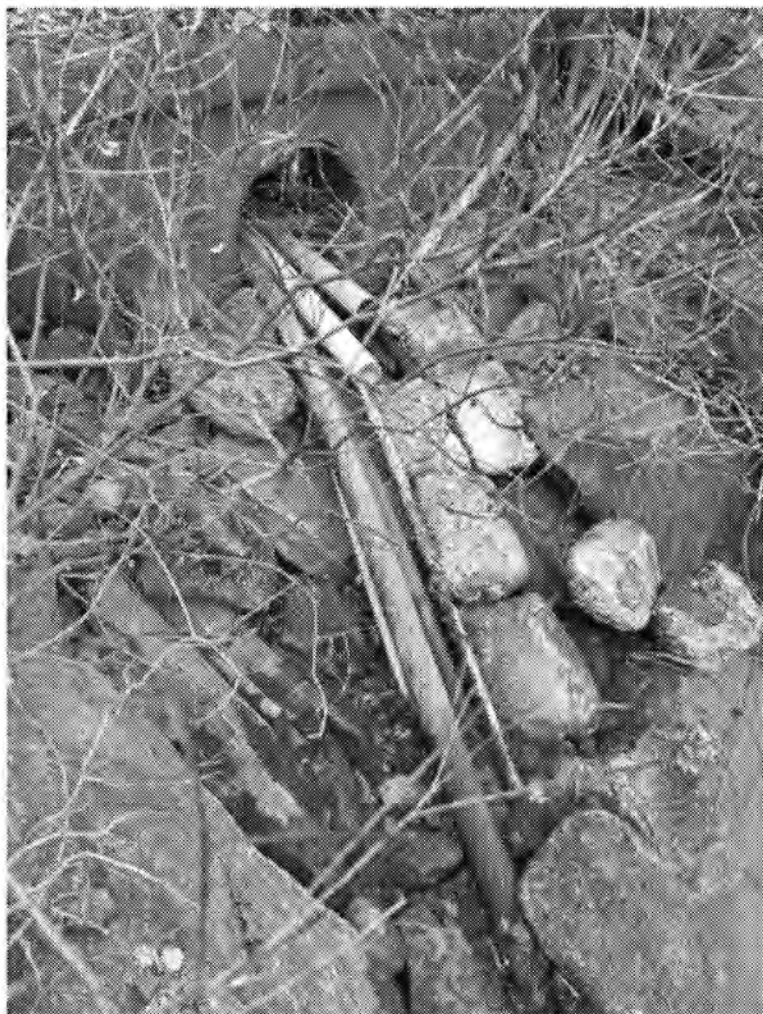
(D) Cables run under the road and into the Hudson River near the Mid-Hudson Bridge at Point of Interest: Hudson 3.1, January 2023. Highland, New York.

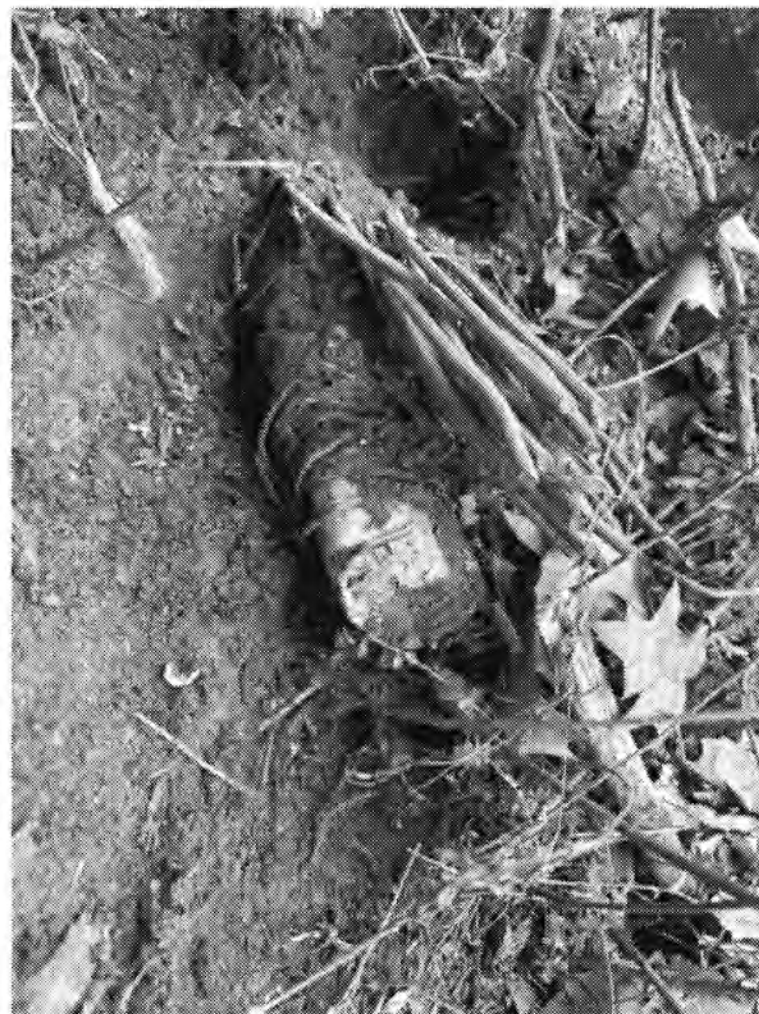
(E) Severed cable and steel wire at the base of an old telephone pole, across from those shown in (D). Point if Interest: Hudson 3.4. January 2023. Highland, New York.

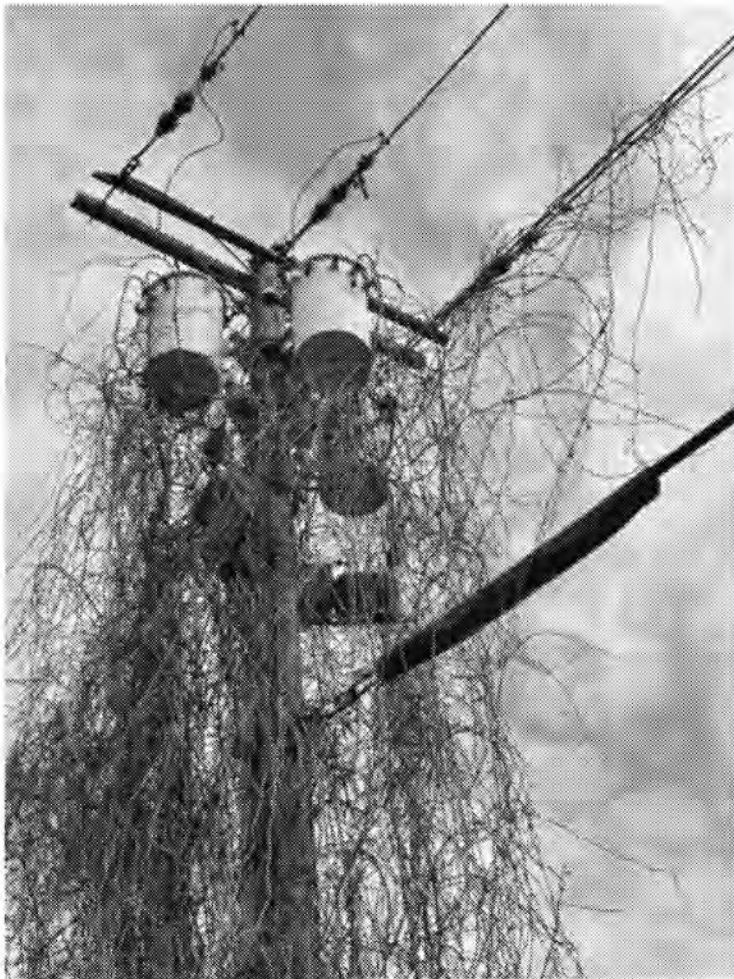
(F) "Squirrel Guard" tied around an exposed area of lead sheathed cable. Point of Interest: Newburgh 1. January 2023, Newbury, New York.

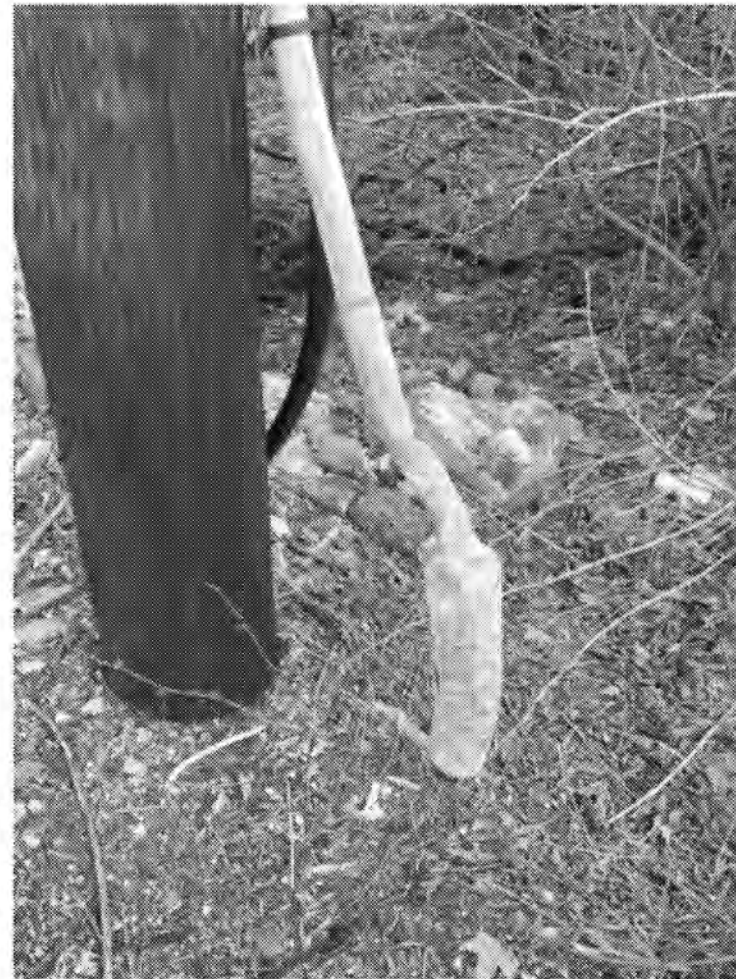
(G) Damaged lead cable and splice box at the base of an old telephone pole. Point of Interest: New Windsor 1. January 2023, New Windsor, New York.

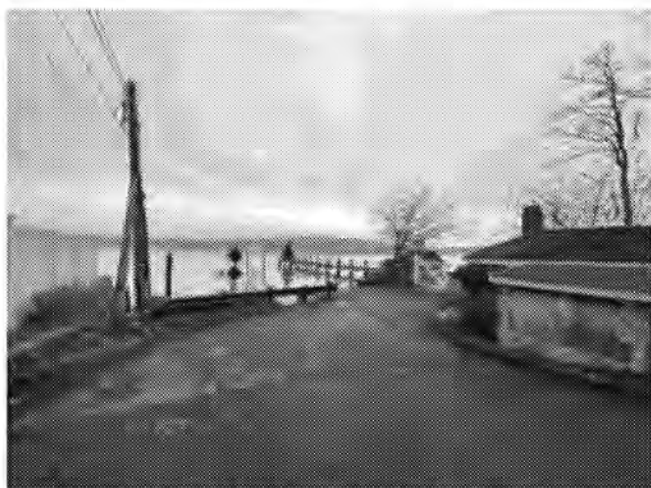
(H) Abandoned 5" lead sheathed cable along the Hudson River. January 2023, Palisades, New York.

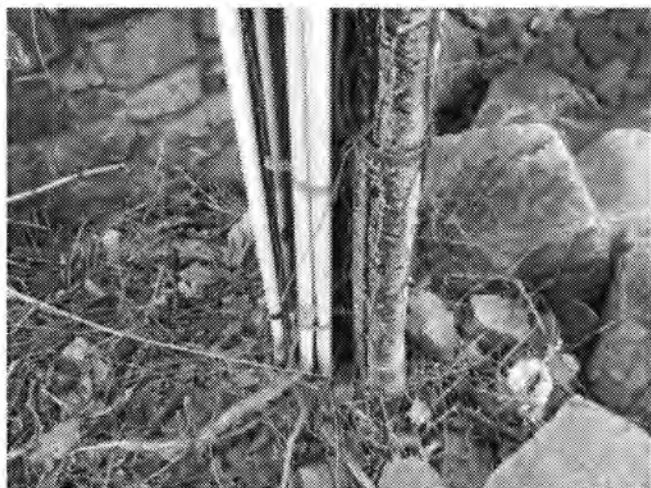
(I) Close up of abandoned 5" lead sheathed cable along the Hudson River. January 2023, Palisades, New York.

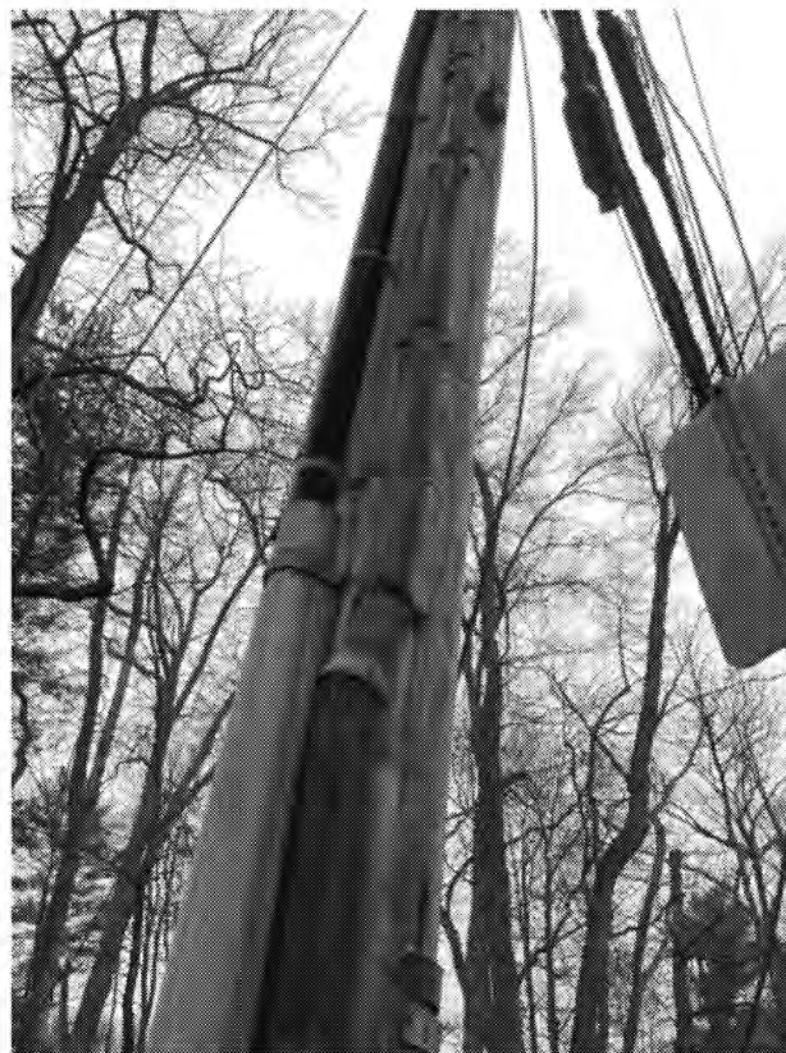
(J) Bare lead sheathed cable running up telephone pole in the Palisades. January 2023, Palisades, New York.

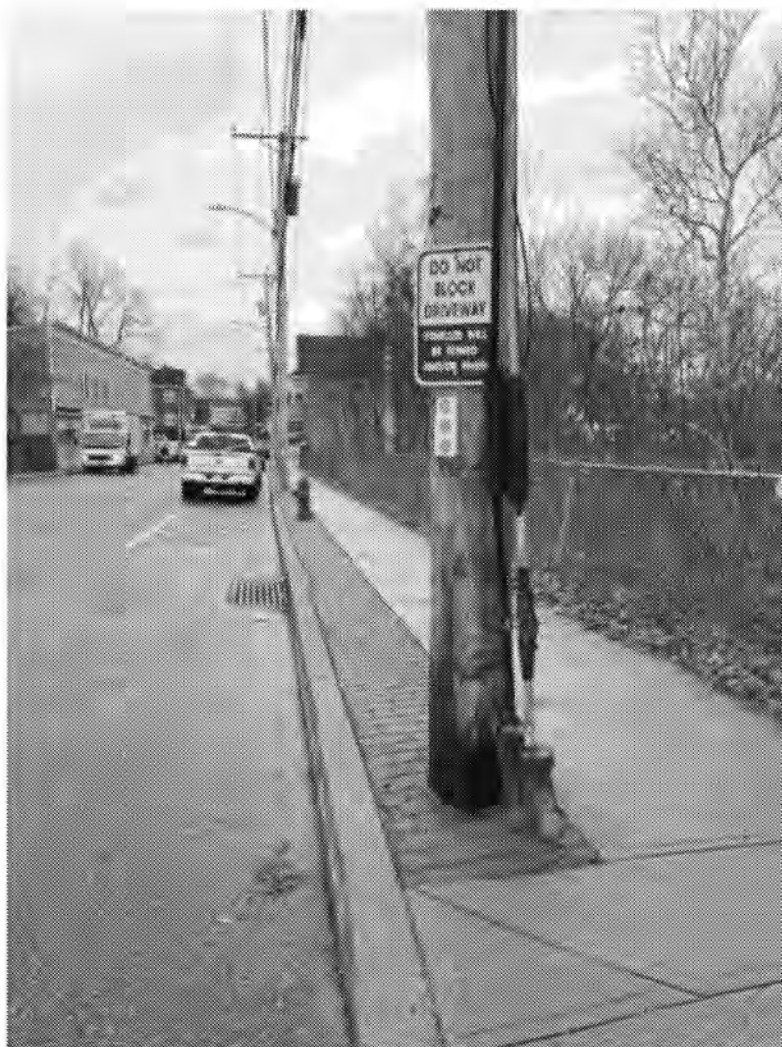
(K) Damaged lead sheathed cable at the base of a telephone in Wappingers Falls, Point of Interest: Wappingers Falls 3, January 2023, Wappingers Falls, New York.

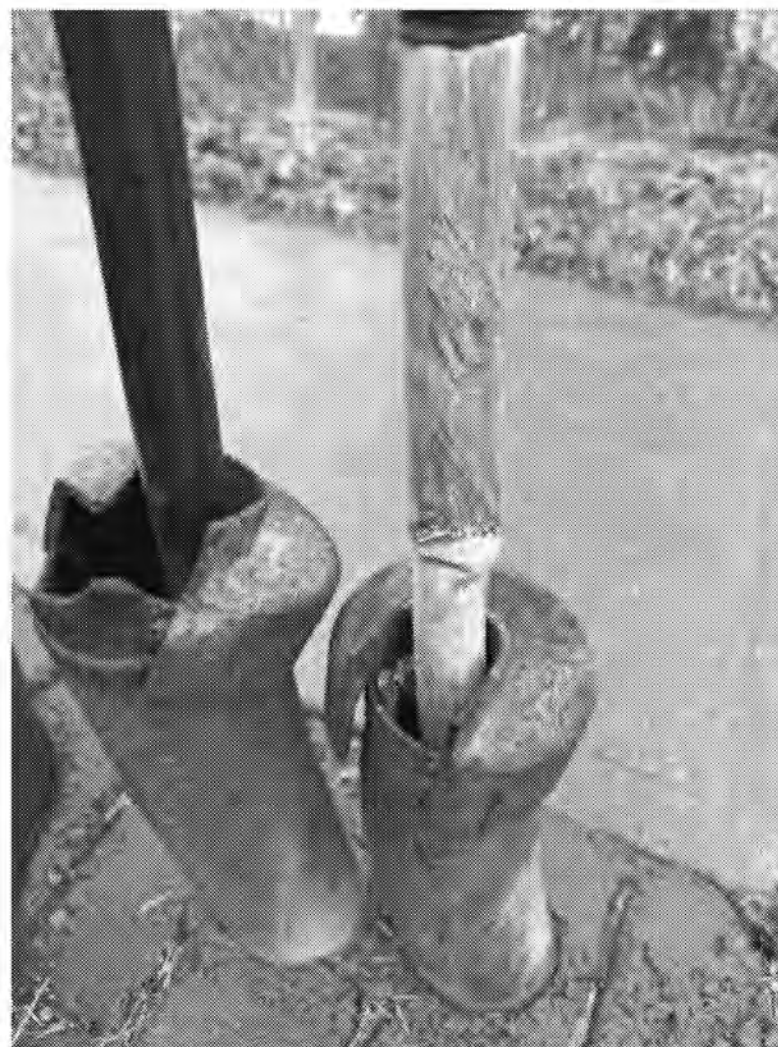
(L) Close up of damaged lead sheathed cable shown in (K). Wappingers Falls 3, January 2023, Wappingers Falls, New York.

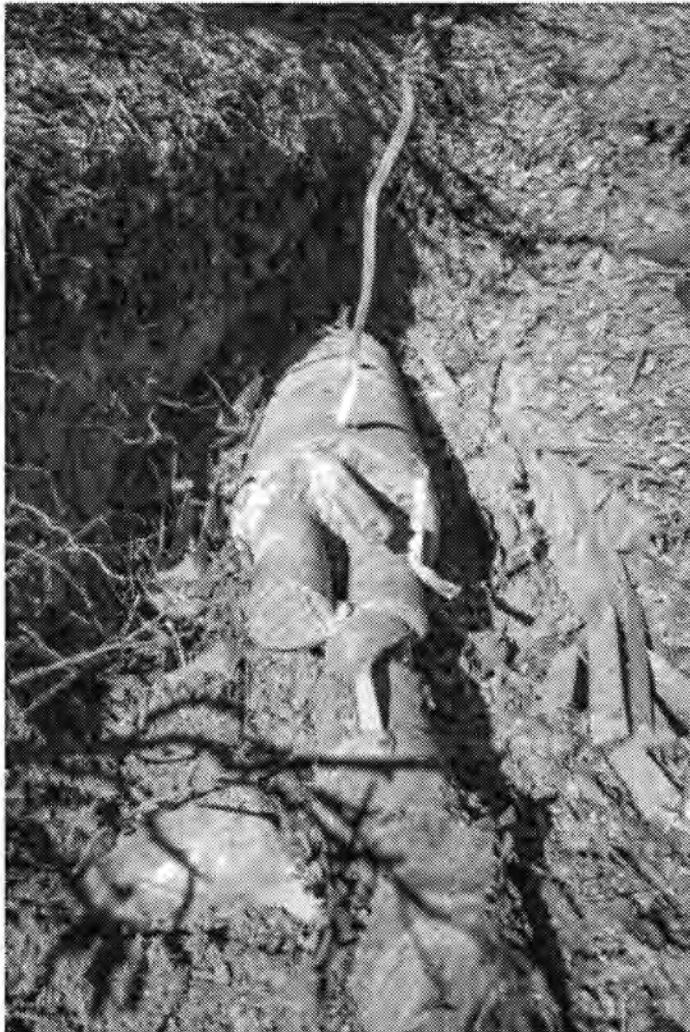
(A) Severed lead sheathed cables, and lead splice box on land. This photo was during a site visit with AT&T in January 2021.

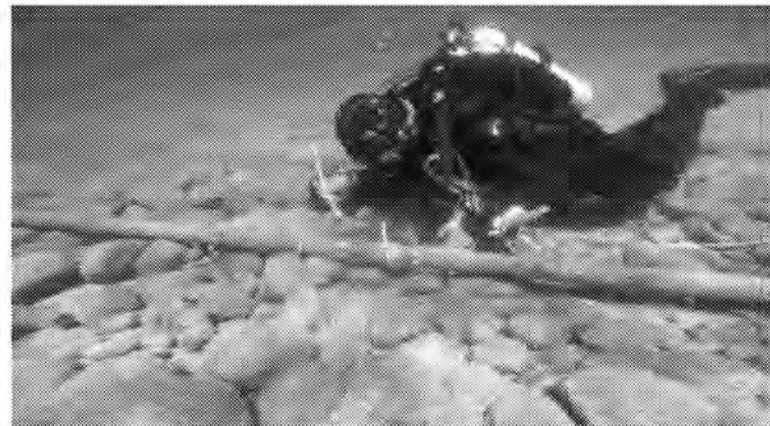
(C) Diver marking locations of damage during a survey in April/March 2022, Lake Tahoe, California.

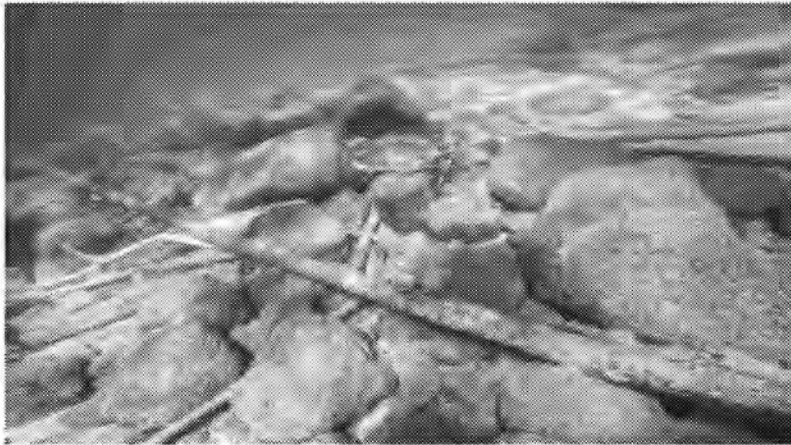
(D) Lead sheathed cable laying among boulders on the lake bottom. April/March 2022, Lake Tahoe, California.

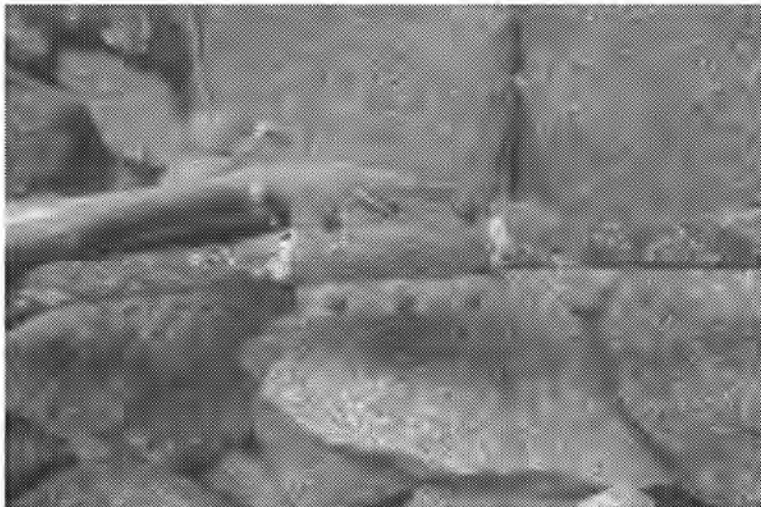
(E) Part of a broken anchor on the cable near Rubicon. April/March 2022, Lake Tahoe, California.

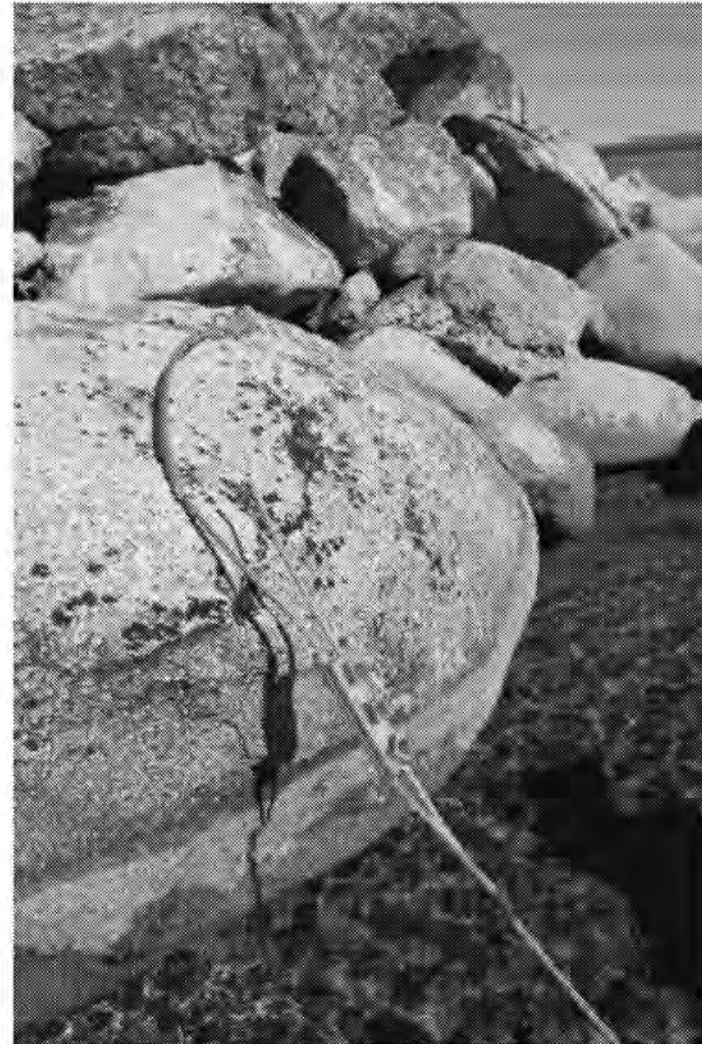
(F) Broken cable anchor on land near Rubicon. April/March 2022, Lake Tahoe, California.

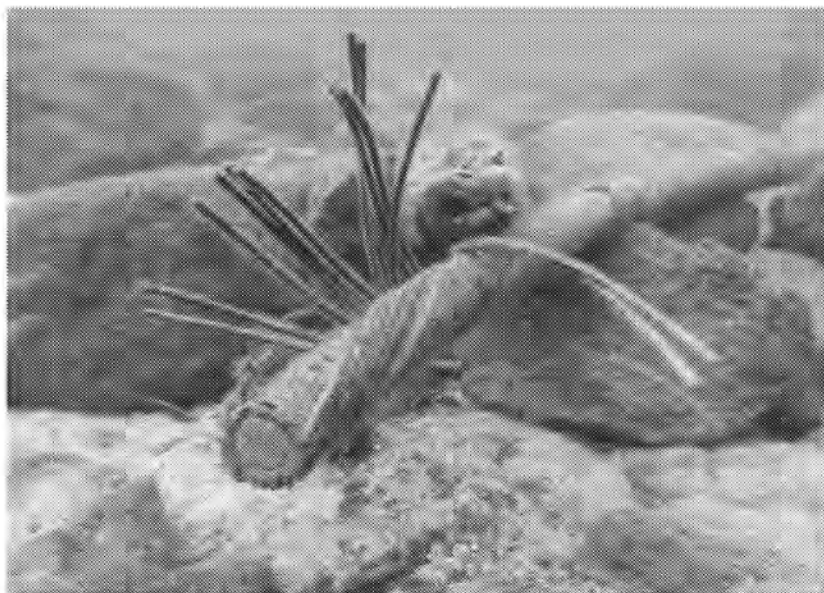
(G) Severed end of 1920's cable in Emerald Bay. May 2021, Emerald Bay - Lake Tahoe, California.

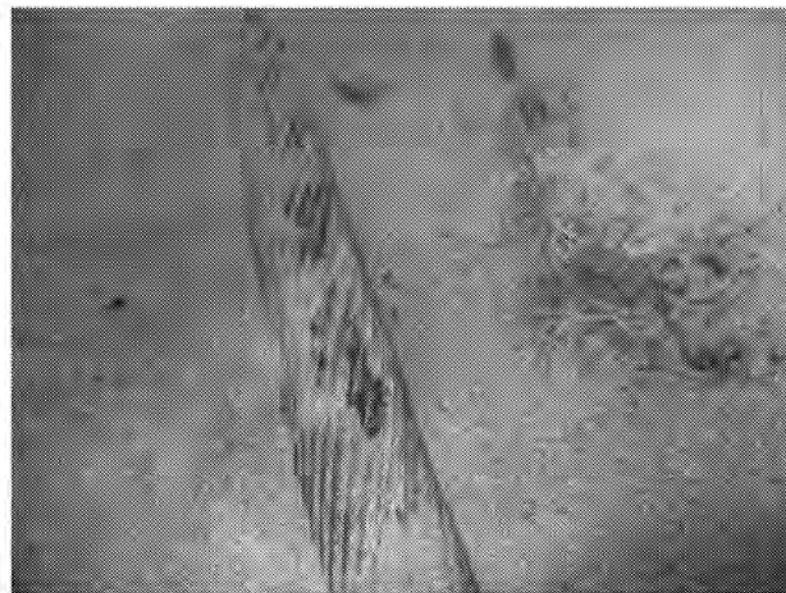
(H) 1920's lead sheathed cable resting on the lake bottom in Emerald Bay. May 2021, Emerald Bay - Lake Tahoe, California.
